Aviation Division

Final report No. 2148 by the Swiss Accident Investigation Board SAIB

On potential risks of ballistic para-
chute systems (BPS) in aircraft to
rescue and investigation crews

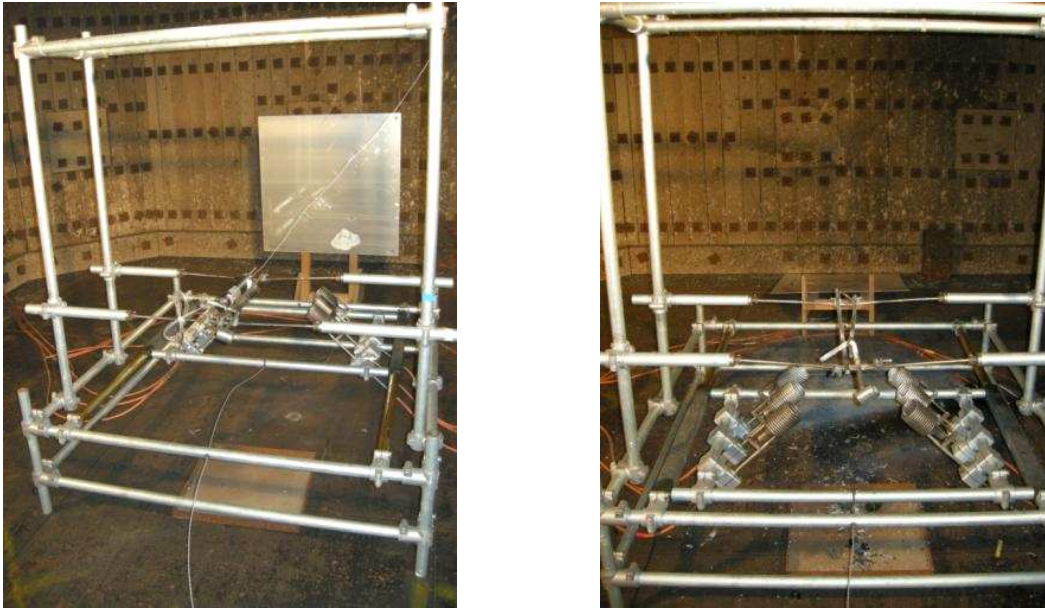
Fig. 4: FCO test V01 of BRS 440; before (left) and after the test (right).

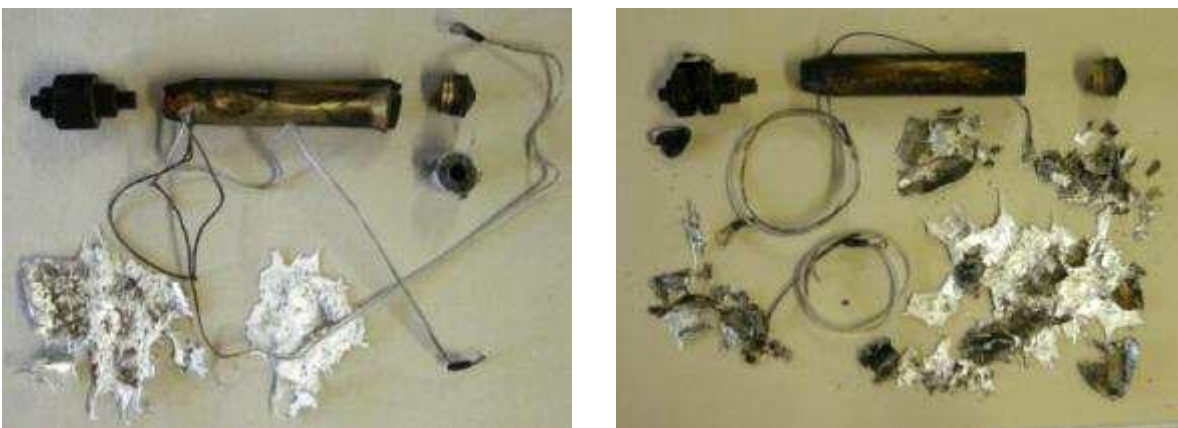
Fig. 6: FCO results for the BRS 440 respectively for test V01 (left) and test V03 (right).

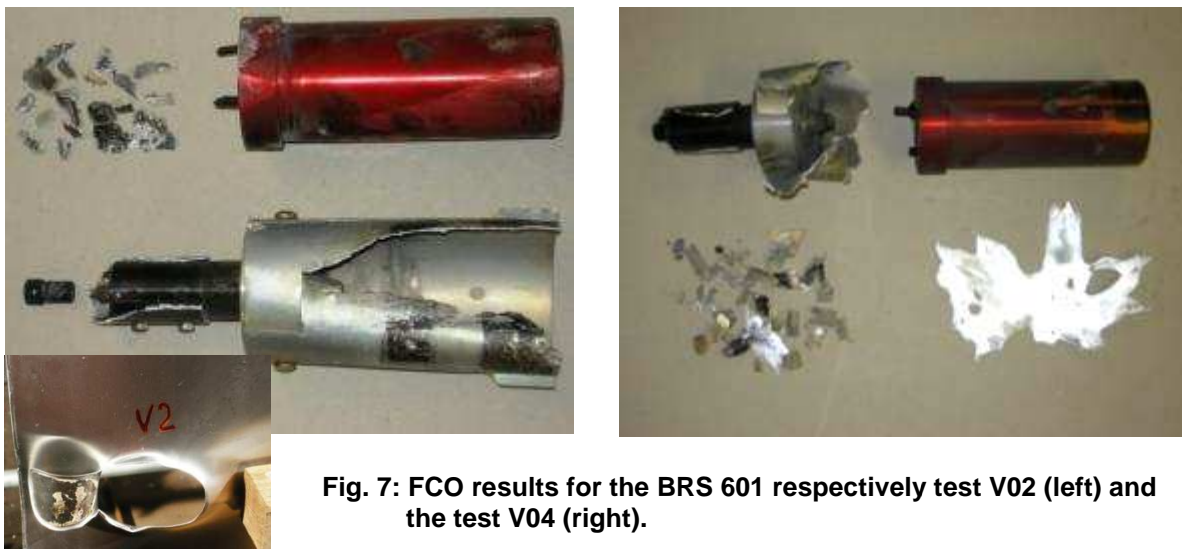
Fig. 7: FCO results for the BRS 601 respectively test V02 (left) and the test V04 (right).
