Aviation Division

Final report No. 2148 by the Swiss Accident Investigation Board SAIB

On potential risks of ballistic para-
chute systems (BPS) in aircraft to
rescue and investigation crews

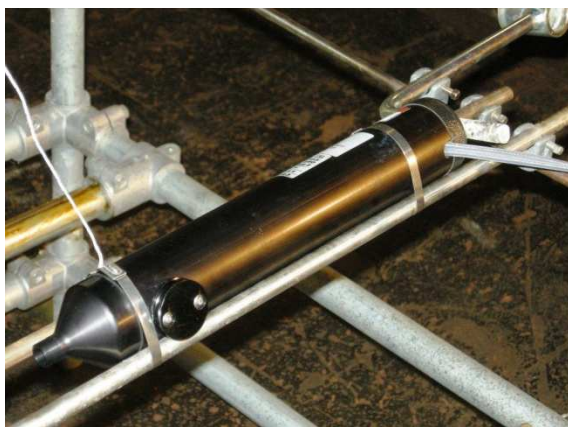
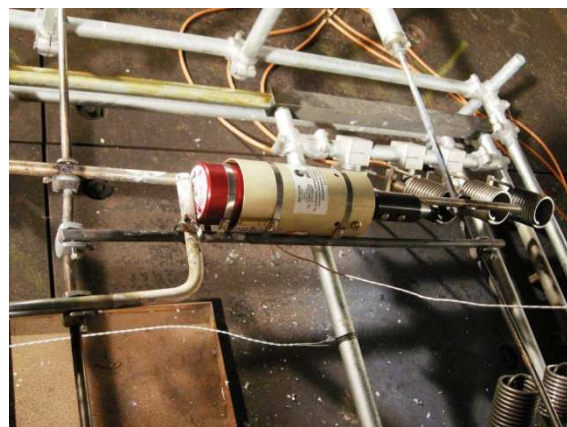
Fig. 3: FCO set-up; respectively for the BRS 440 (left) and the BRS 601 (right).

Test Nr. / Rocket	Mean Temp. [°C]	Time to Reaction [s]	Type of Reaction ¹	Remarks
V01/ BRS 440 Nr. 2	1045	145	Type V-IV Fast burning towards deflagration	End cap was axially ejected out of the rocket casing with high velocity. The main part of HTPB cylinder of the rocket motor did not react. Both percussion cups of the Igniter did not react.
V03/ BRS 440 Nr. 3	1085	129	Type V-IV Fast burning towards deflagration	The end cap was axially ejected out of the rocket casing with high velocity. One wire cut and the second wire almost cut. No unreacted rocket motor parts left. Igniter including primary booster remained unreacted.
V02/ BRS 601 Nr. 1	1050	43	Type V-IV Fast burning towards deflagration	The rocket was axially ejected apart from the fixation and penetrated the 2 mm thick aluminum witness plate (see Fig. 7). The outer casing of the rocket was ejected to the opposite witness plate which resulted in a crack into the plate. All parts of the rocket motor and igniter did react.

V04/ BRS 601 Nr. 2	1065	69	Type V-IV Fast burning towards deflagration	The rocket remained onto the support but shifted the whole test equipment about 1.5 m in the direction of the base of the rocket. All parts of the rocket motor and igniter did react.

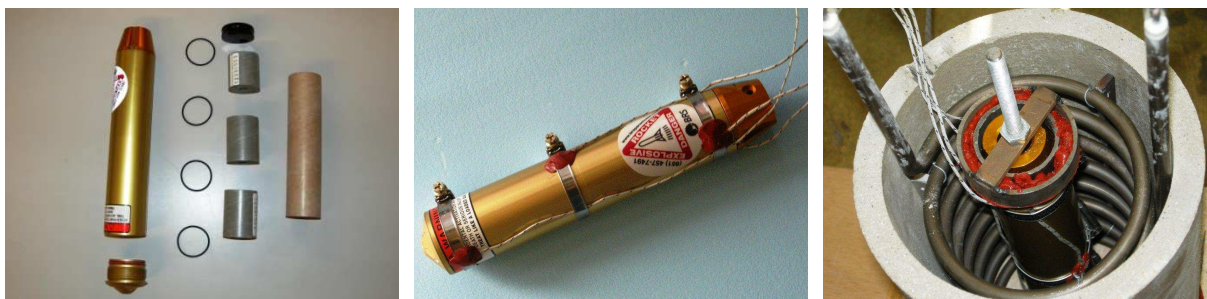
Fig. 8: Arrangement of the BRS 440 rocket for the SCO test; respectively rocket with probes and in position in the brick cylinder.

Only one type of BRS rocket was left to perform an indicative SCO experiment; BRS 440 Nr. 1 which was used for dismantling. The test was performed without Igniter (used for analytical tests) and with an aluminum disc of 1 cm thickness for confinement towards the rocket nozzle. The first HTPB cylinder of the rocket motor weighted 57.3 g instead of 71.3 g. We have chosen a heating rate of 15°C/h for this experiment which corresponds to a realistic heating rate for the thermal radiation of a fire in the vicinity.

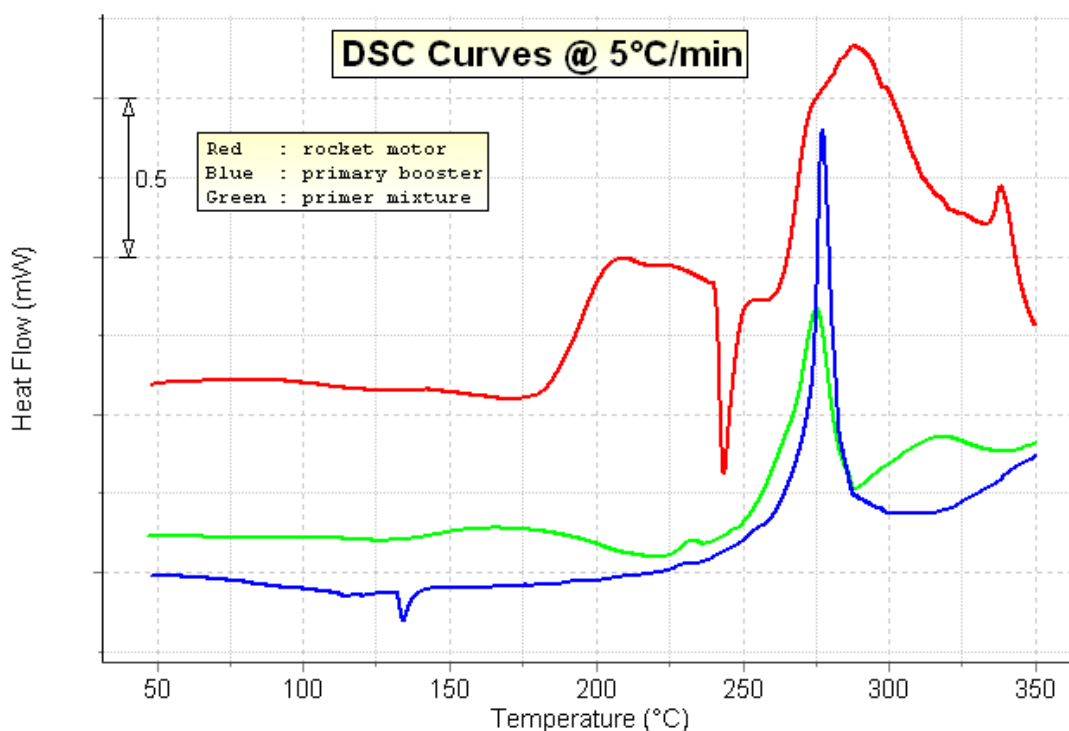
Fig. 11: DSC curves of the rocket motor, the primary booster and the primer mixture with a heating rate of 5°C per minute.

The DSC experiments have shown that for a heating rate of 5°C per minute, the rocket motor is the sample which shows first an exothermic reaction at 180°C (cf. fig. 11). In comparison the primary booster and the primer mixture seem to be thermodynamically more stable.

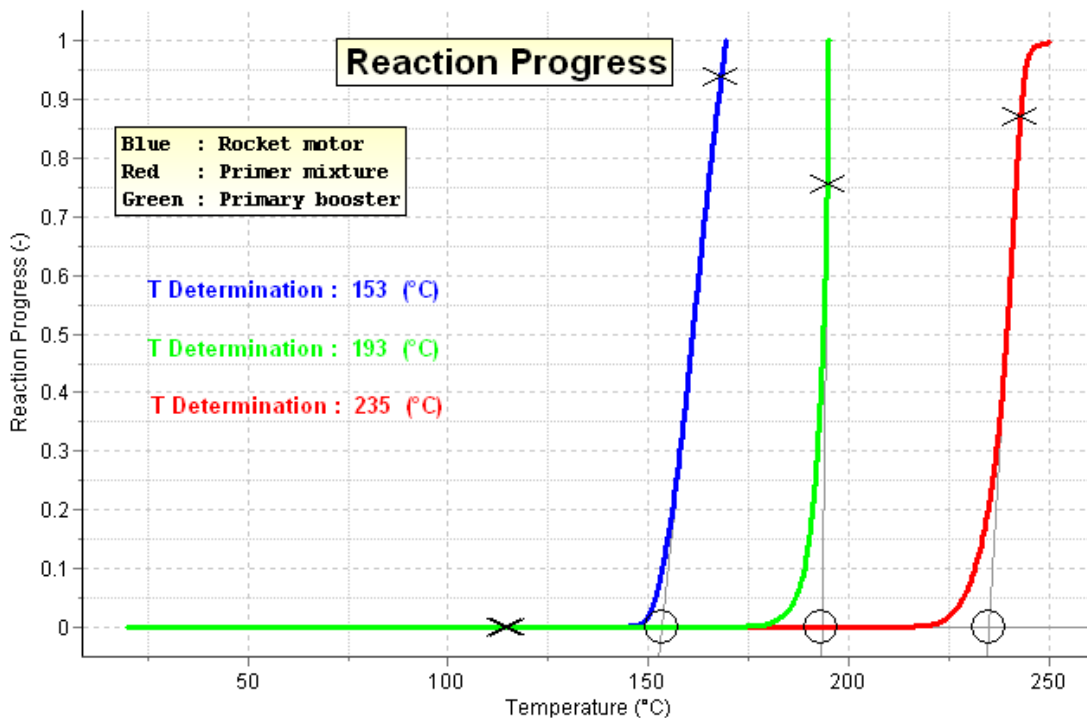
Fig. 15: Prediction of the reaction progress under adiabatical condition for a heating rate of 15°C per hour; the blue curve represents the rocket motor, the green curve the primary booster and the red curve the primer mixture.

For the thermodynamical simulations we had to make a compromise due to the high inhomogeneity of the sample in the milligram domain. This was especially the case for the HTPB rocket motor. For the simulation we could use only the first exothermic peak (up to 220°C) instead of the full spectrum as for the other two substances. Figure 15 shows the reaction progress of the three samples in an adiabatically configuration. Although that this condition does not totally fulfill to the SCO test set-up, it is reasonable to assume that with a heating rate of 15°C per hour, the rocket motor will probably react first.

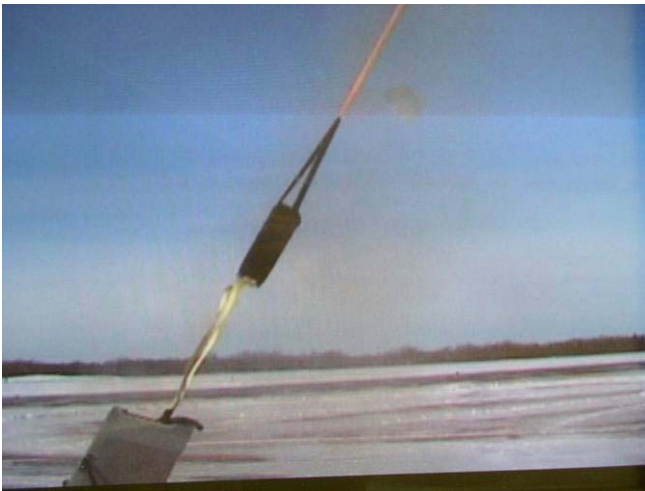
The rocket motors are ignited by pulling an activation handle in the cockpit. They then accelerate to over 100 mph in the first tenth of a second after ignition. While the total firing period is only one second, someone in the path of an escaping rocket could be seriously injured or killed. These are powerful rockets (about 1½-2 inches diameter and 8-10 inches long) that work very efficiently. At left is a test of a Cirrus system showing the 55 pound parachute pack being pulled by the rocket motor. This is a fraction of a second after ignition.

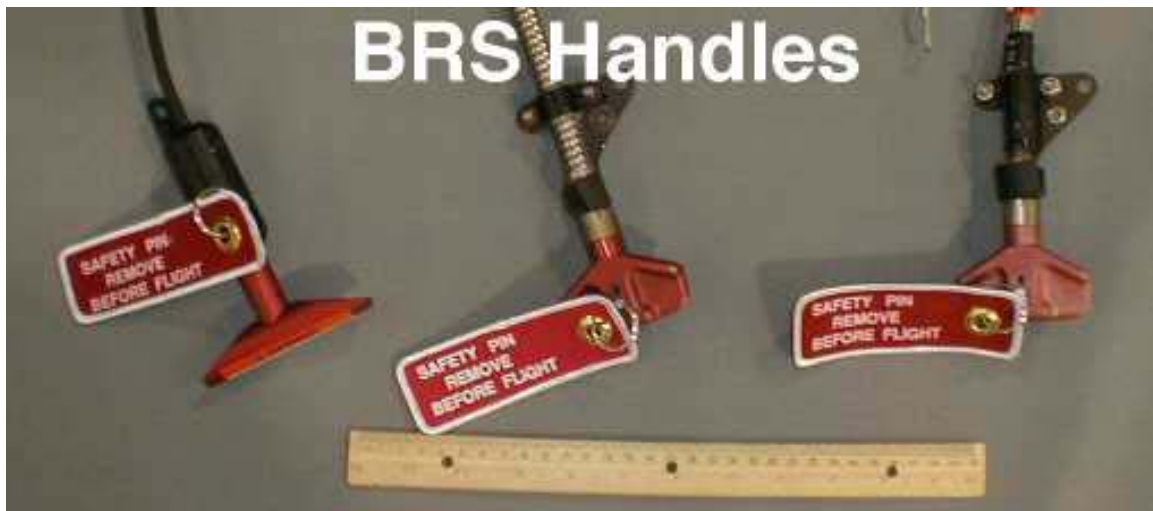
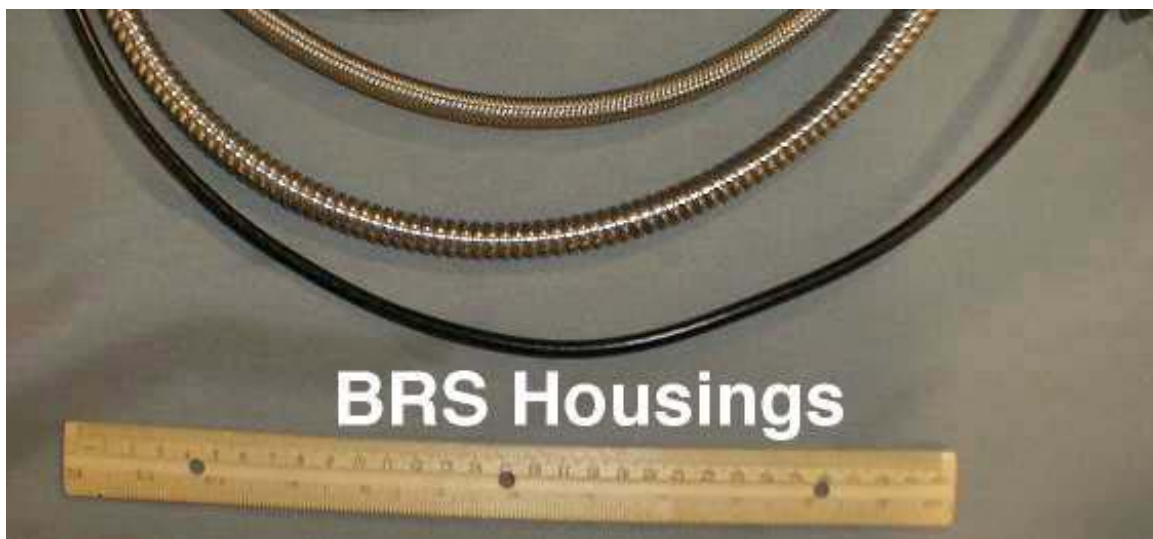
The first thing emergency people may see is a red firing handle. This will be located near the seats, as it obviously must be close to the pilot. The red firing handle will connect to the activation housing, the flexible cable that links the firing handle to the igniter.

In the picture below, see that each handle is secured with a safety pin. This is to remain with the handle until the aircraft departs for flight, at which time the pilot should then remove the pin. **A first step for emergency personnel is to place some type of 3/16 inch pin or rod into the handle holder.** This provides some measure of security as you proceed to further disarm the system.

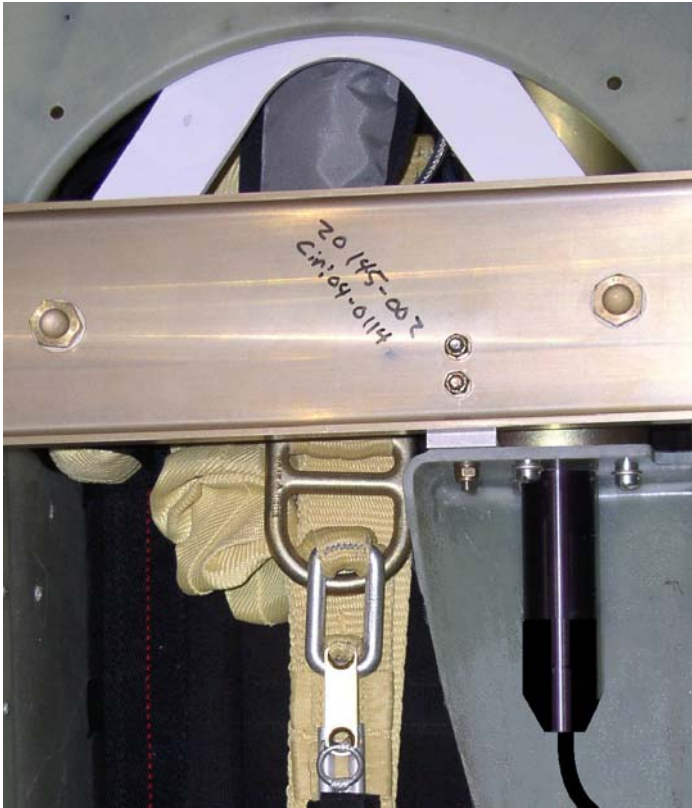
CIRRUS

The photo at left shows the **Cirrus** parachute installed into its storage area, located just behind the baggage compartment. It is normally covered by a sheet metal panel and carpet, which is secured with Velcro. The rocket motor is mostly hidden behind the aluminum beam; the igniter is visible in the upper right center as a black cylinder. The Cirrus parachute is contained within a heavy nylon bag, so it is a *softpack* by definition.

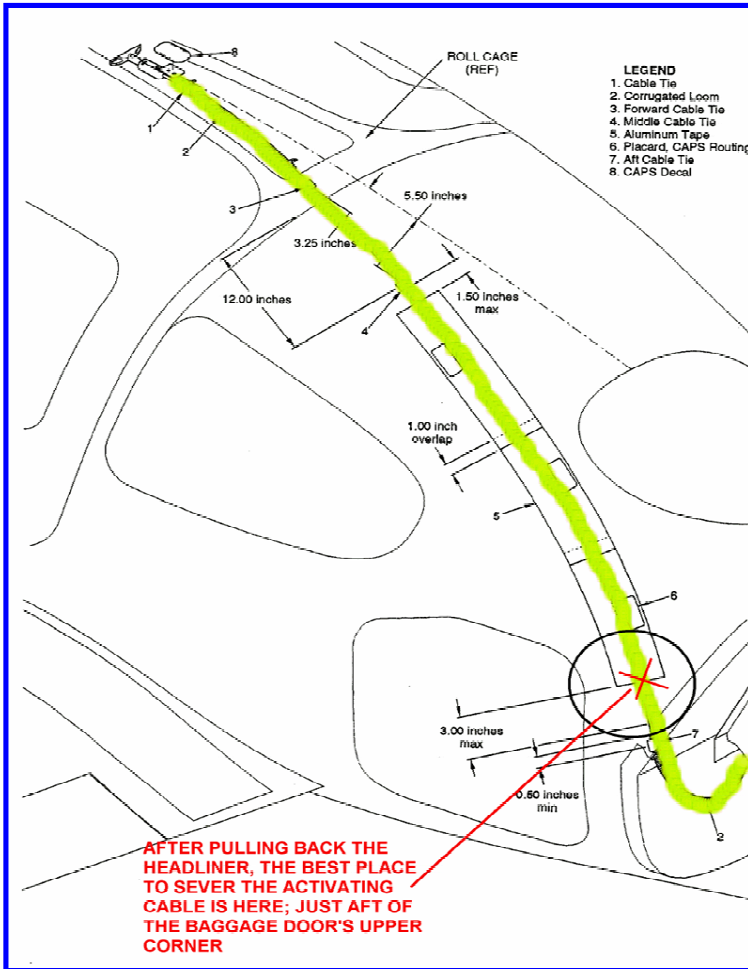
CIRRUS

This illustration shows the routing of the activation cable in a Cirrus SR20 or SR22 aircraft, which is covered entirely by headliner panels. The best place to expose the cable is just aft of the baggage door, near the upper right corner.

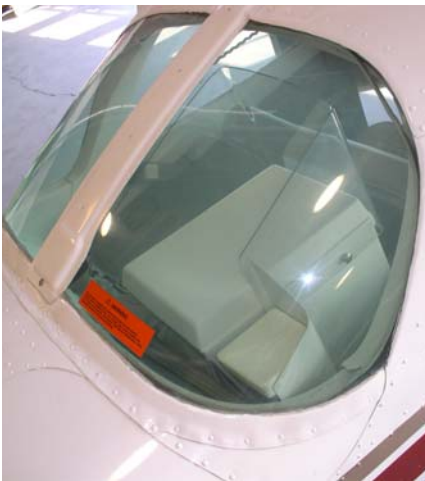
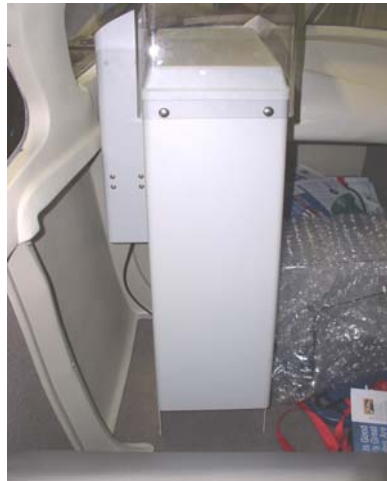
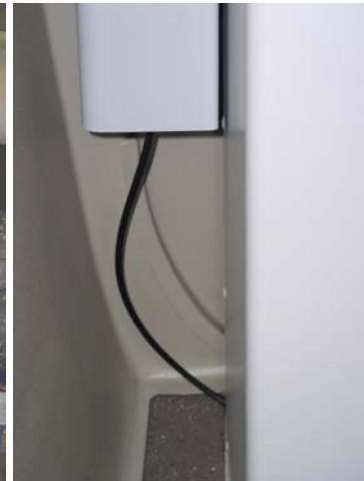
Cessna 172

The above three photos show the location of the parachute canister and rocket in the **Cessna 172**. The aluminum parachute canister (large box) is in the left rear of the

baggage area, as viewed from the front seats. The rocket is on the left of the parachute canister; the activation cable runs down to the floorboard, under a cover, then forward to the activation handle, located near the fuel selector.

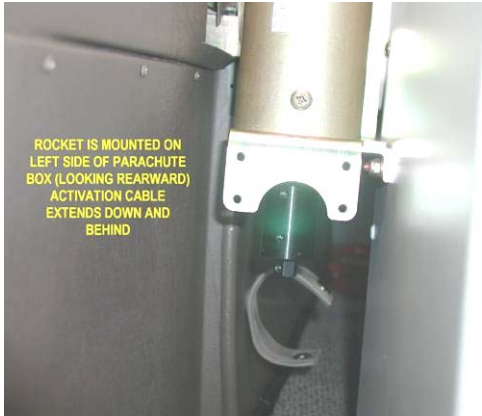
At left, the **C172** rocket and igniter with the plastic cover having been removed. The rocket motor is secured to the igniter base by three 10-32 nylon screws which fracture at firing.

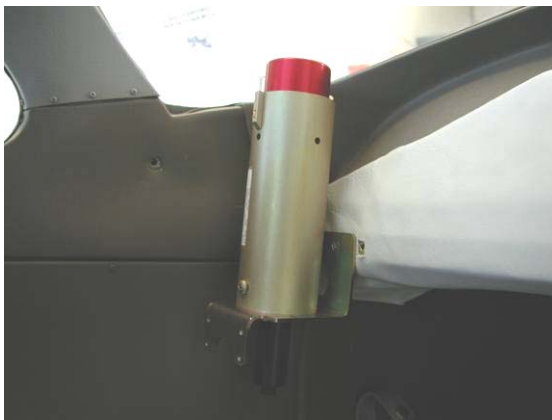
Here is another perspective of the **C172** rocket assembly with cover removed. It is just a few inches below the rear window, which it will readily break through when fired. Inside the launch tube resides the rocket motor, it's the red cylinder.

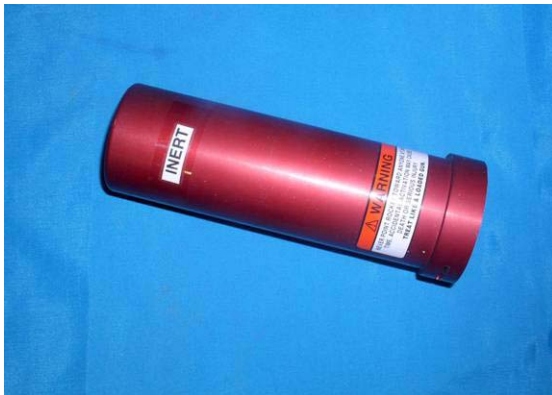
This is a close up of the **BRS 900** rocket motor, common to both Cessna and Cirrus installations. It produces roughly 225 pounds of thrust over a 1.2 second burn time and must be respected. It burns solid propellant derived from military formulations and is very resistant to accidental initiation.

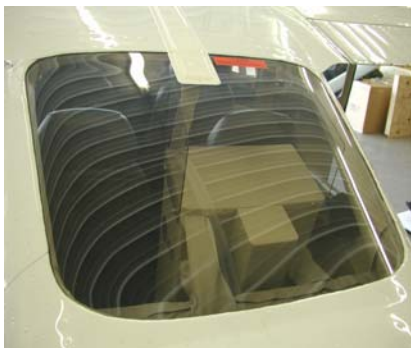
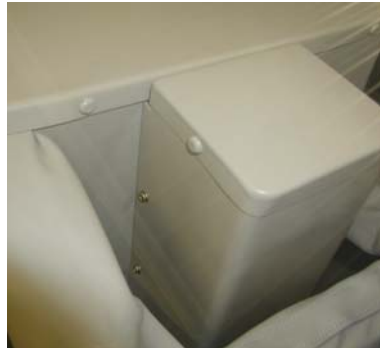
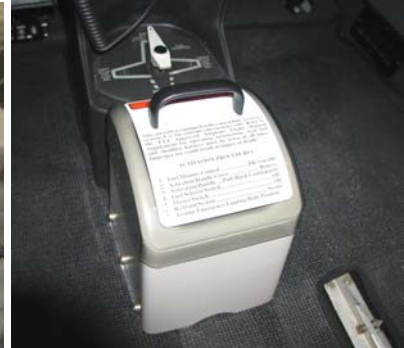
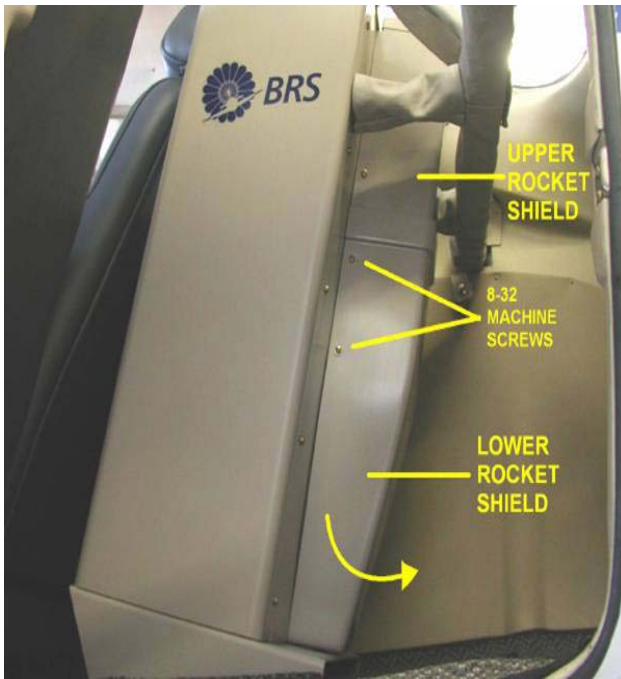
Cessna 182

Many of the design elements of the newer, C182 ballistic parachute system are similar to its predecessor, the C172. The canister is rotated 90 degrees and the rocket is located *aft* of the canister, however, the activation cable is still relatively accessible prior to being covered on the floorboard. The best way to reach the cable would be through the left side baggage door, if possible. As shown here, the rocket motor and igniter are covered by the upper and lower rocket shields, which are intended to protect the components from bumping. To gain access to the cable, perform the following steps:

1. Using a Phillips screwdriver, remove the two 8-32 screws securing the left side of the lower rocket shield
2. Place force on the shield in an effort to move it *away* from the parachute canister. Even though there are two more screws on the right side, it should fracture and may then be pushed out of the way.
3. You will then see the igniter and the activation cable, as at left.
4. Using the Felco cutter, or equivalent, proceed to cut the cable 1" - 2" from the end.
5. The rocket has now been rendered safe, and it may be removed for disposal or safe storage.

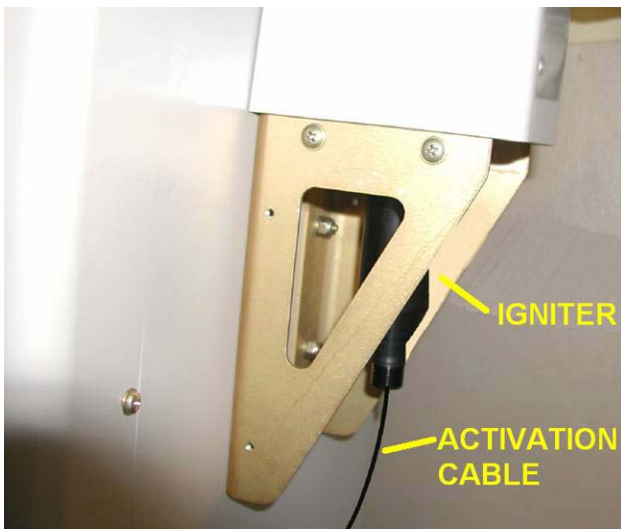
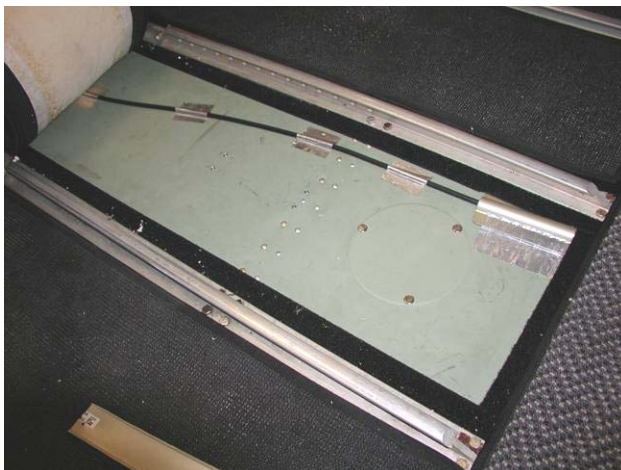
Note: This photo shows the routing of the activation cable between the front seats in either C172 or C182 installs. It is partially protected by aluminum channel, as you see in the right of the photo. Aluminum tape is also used to secure the cable to the floor. For any reason, should you be unable to access the cable near the igniter, this is a secondary point of access.

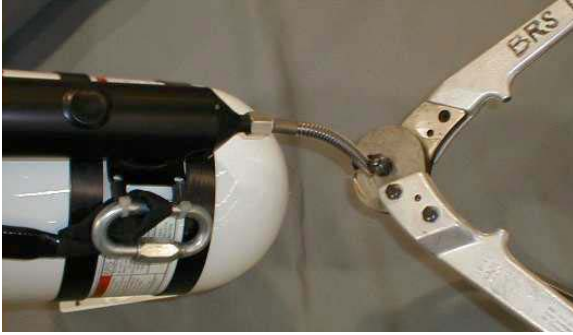
This photo shows the larger **Felco C16** cutter being used to sever one of the older style, stainless steel cable assemblies.

BRS **STRONGLY RECOMMENDS** using a Felco-brand cutter, which is sold in several models from the compact C7 to the larger C16. They can be obtained from various sources, including Sanlo Manufacturing Co: <http://www.sanlo.com/product/tools.htm>.

NOTE: DO NOT ATTEMPT TO CUT THE ACTIVATION HOUSING WITH AN ORDINARLY BOLT CUTTER OR SIDE CUTTER! They are **NOT** effective at cutting the cable housing. The Felco or Greenlee brand cutters gather the cable and work with surprising ease. They make a worthy
